Manhole Inspection Summary

Manhole # S35UU1029MH

Insp Date: **1/31/07 2:54 PM**

Location Address: **318 PADDINGTON RD**

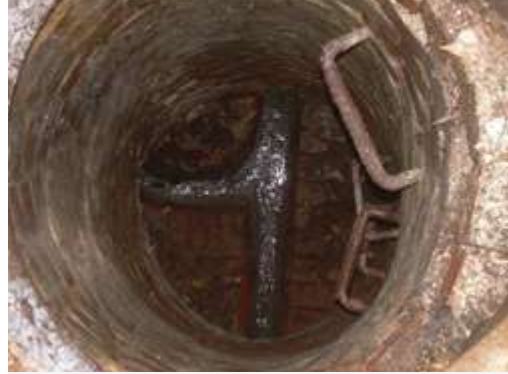
Top View

Corroded steps. Evidence of surcharge - Bench debris.

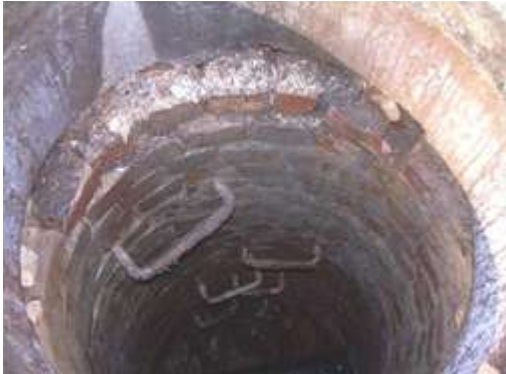
Defect

Frame offset. Frame leaks. Adjustment deterioration, loose brick and infiltration. Corbel and Barrel infiltration.

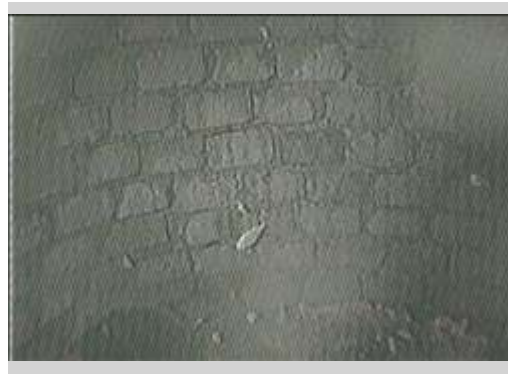
Defect

Barrel deterioration and infiltration.

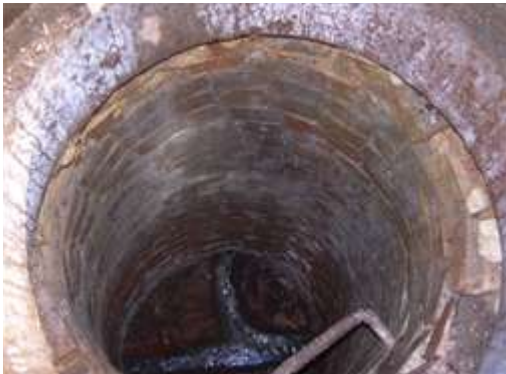
Defect

Frame offset. Adjustment deterioration, loose brick and infiltration. Corbel and Barrel infiltration - other side.

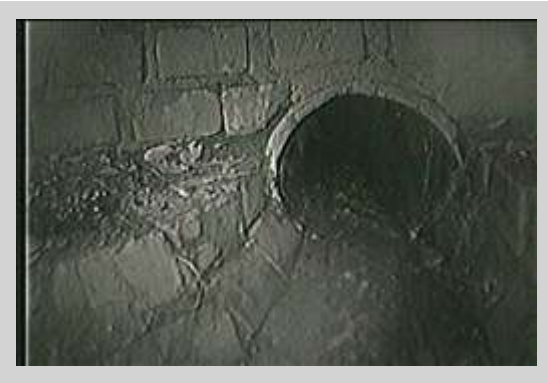
8 in. Circular Gravity Sewer Pipe Out @ 12 O'Clock

Channel deterioration and root intrusion.

Infiltration: **Evidence** Pipe Seal Cond: **Unknown**

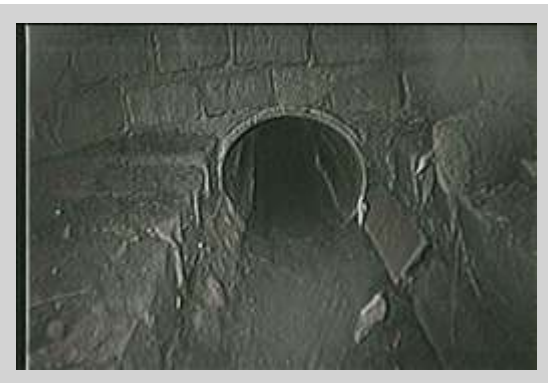
8 in. Circular Gravity Sewer Pipe In @ 6 O'Clock

Channel deterioration.

Infiltration: **Evidence** Pipe Seal Cond: **Cracked**

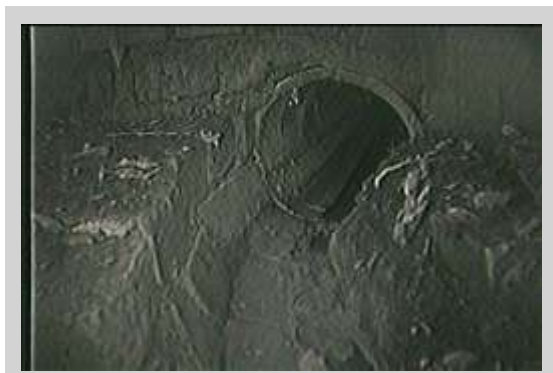
Pipe In @ 9 O'Clock

Channel root intrusion.

Infiltration: **Evidence**
